Wood-frame construction in past earthquakes

Rainer, J. Hans¹, Karacabeyli, Erol²

ABSTRACT

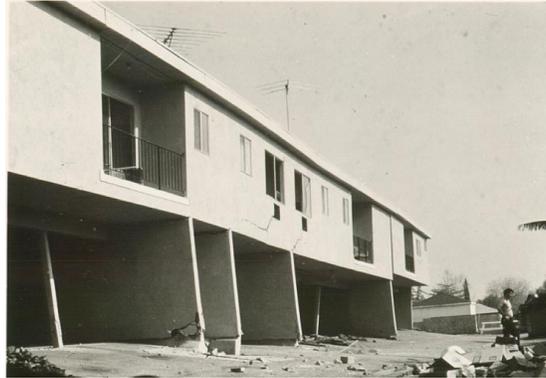
Older wooden houses in the San Fernando area suffered damage ranging from minor to partial collapse. Newer two-storey apartment buildings with large ground-level openings were also severely affected. See Figure 1. These damage cases can be categorized as follows: houses sliding off the foundations; collapse of cripple walls in crawl space; collapse of add-ons such as porches; collapse of masonry chimneys; major distortion of weak first storey. A detailed damage survey is presented by the Pacific Fire Rating Bureau (1971).

Figure 1 Damaged two-story building with weak first storey; San Fernando Earthquake, 1971.

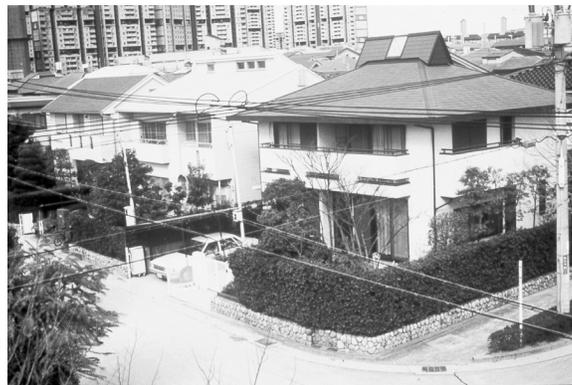
Among the sea of devastation of older style houses were examples of modern wood construction and wood-frame houses (Figure 2) that showed no visible signs of distress (APA 1995). Of approximately 8000 "2 by 4" houses, none collapsed and 70% reported no damage (Two by Four news 1995). Most of these houses were located in areas of severe shaking and again demonstrate that modern wood-frame construction can withstand earthquakes with peak ground accelerations of 0.6 g or more with little or no damage.

Figure 2 Undamaged "2x4" wood-frame houses in Ashiya City near Kobe, Japan, after Hyogo-ken Nanbu Earthquake, 1995.
