Wood-frame construction in past earthquakes

Rainer, J. Hans¹, Karacabeyli, Erol²

ABSTRACT

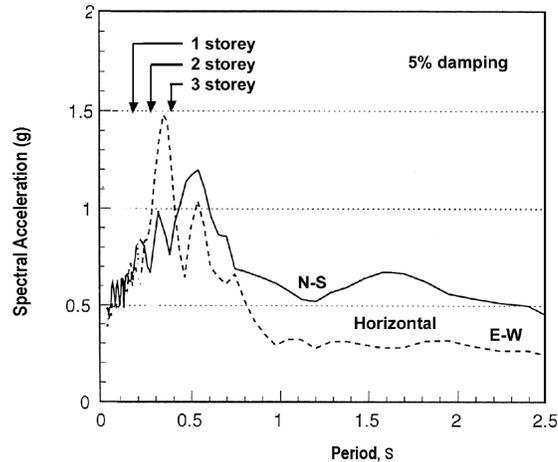
The loading imposed on the building by the seismic ground motion is depicted by the response spectrum, an example of which is shown in Figure 3. An examination of the acceleration response spectra for the Kobe, Northridge, Loma Prieta, Edgecumbe, and San Fernando earthquakes shows that the spectral response increases from the PGA at zero period to a maximum at a period of about 0.3 to 0.4 s. Given that the first natural period of single-storey houses are at an average of 0.13 s (Madaris 1978, Rainer et al. 1988), two-storey houses at 0.23 s, and three-storey houses (by extrapolation) at 0.33 s, it may be seen from Figure 3, for example, that the two or three-storey building is subjected to a larger spectral acceleration and consequently acquires the larger base shear than the single-storey building. If, in addition, the approximately 3 times greater additional mass for the three-storey building is taken into account, it may be seen that the base shear to be resisted by the three-storey building has to be many times larger than for the single-storey house. It then follows that if the same good performance is desired for the multi-storey wood-frame buildings as was demonstrated for the single-storey ones, the former will have to possess a base shear resistance per unit area many times that of a single-storey house. Conversely, construction of multi-storey wood-frame buildings to the same requirements as single-storey houses will not result in comparable seismic performance. This phenomenon is particularly important for the seismic-resistant construction of conventional multi-storey wood-frame buildings.

Figure 3 Response spectrum for Northridge Earthquake 1994, 18350 Rosco Blvd., Northridge, California. Adapted from Johnson and Pierepiekarz (1994).
